North Coast Regional Water Quality Control Board

Inspection Report

Site: Leif Stafslie
CIWQS Place ID: 843698
Inspection Date: May 23, 2019

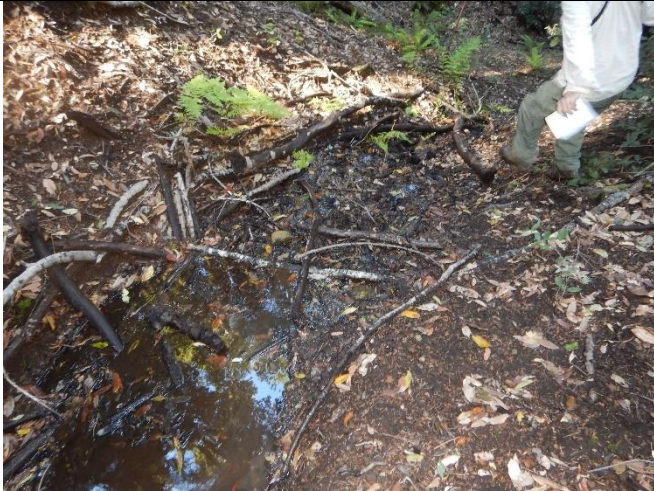
Spring – I observed a spring with surface water flowing for approximately 50 feet downhill (photo 1). Surface flow dissipated near two empty water storage tanks and no channel was visible downstream (photo 2). There was no diversion infrastructure in the spring. Mr. Stafslie stated he no longer diverts from the spring.

Photo 1 – Spring; surface flow from spring

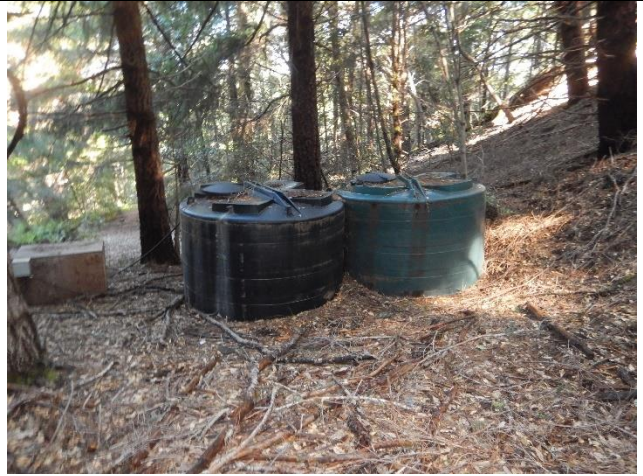
Photo 2 – Spring; surface flow from the spring dissipates near two empty water storage tanks

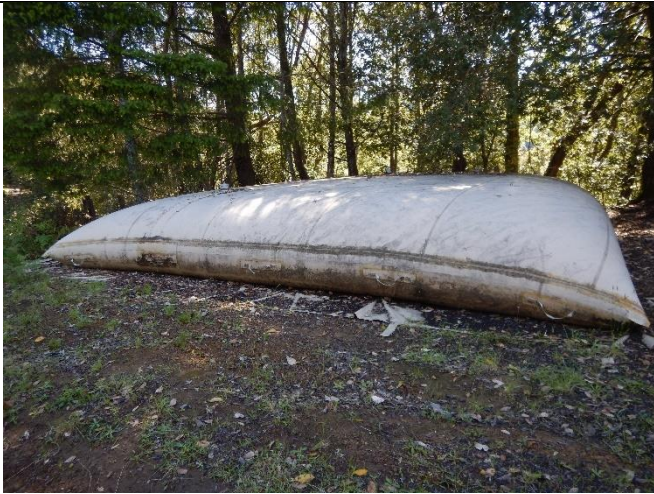
Bladder – I observed a full 20,000-gallon water storage bladder on a flat area adjacent to a steep hillside (photo 3). The bladder did not have secondary containment.

Photo 3 – Bladder; water storage bladder

1. Discontinue use of water storage bladder or provide a secondary containment system with the ability to capture 110 percent of the bladder's capacity in the event of bladder failure. Secondary containment systems shall be of sufficient strength and stability to withstand the forces of released contents in the event of catastrophic bladder failure. In addition, secondary containment systems that are open to the environment shall be designed and maintained with sufficient capacity to accommodate precipitation and storm water inputs from a 25-year, 24-hour storm event.

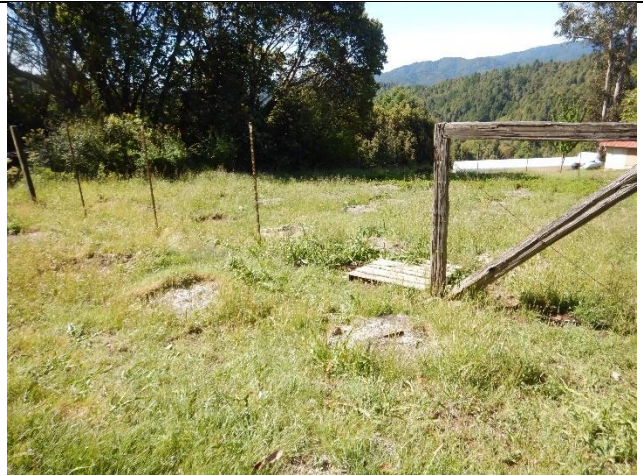
Decommissioned Cultivation Area – I observed a vegetated, former cannabis cultivation area (photo 4).

Photo 4 – Decommissioned Cultivation Area; vegetated former cultivation area

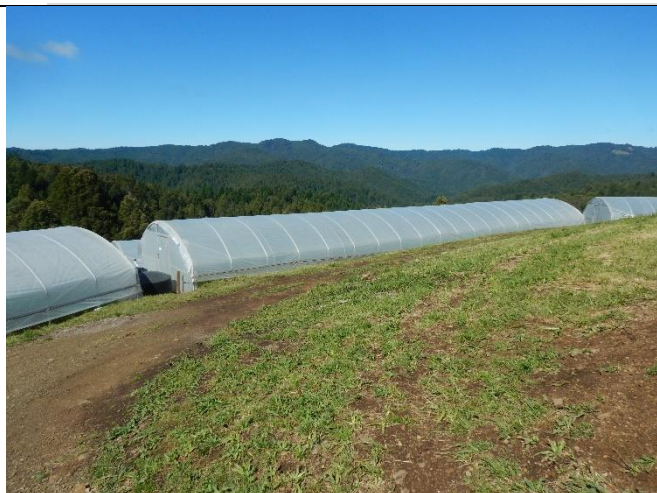
Cultivation Area 1 – I observed an active cultivation area with cannabis plants in raised beds in six hoop houses (photo 5).

Photo 5 – Cultivation Area 1; six hoop houses with cannabis plants in raised beds

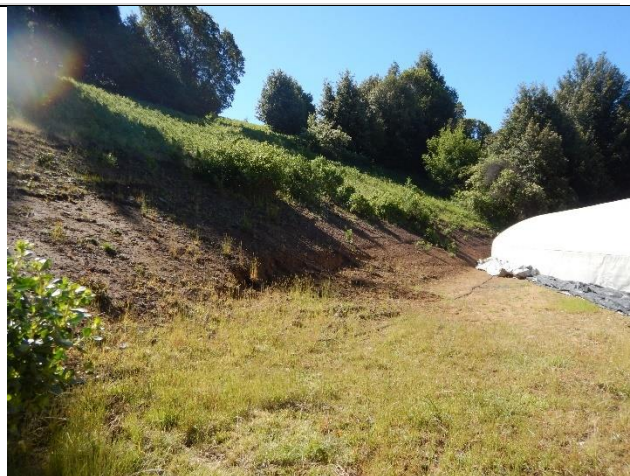
Cultivation Area 2 – I observed an active cannabis cultivation area with three hoop houses. Adjacent to the hoop houses was a bare cut slope with sediment accumulated at the base (photo 6).

Photo 6 -Cultivation Area 2; three hoop houses with cannabis plants and bare slope

2. Revegetate bare slope in Cultivation Area 2
3. Add a ditch relief culvert at the outlet of the Drainage Path to convey water to the vegetated flat on the other side of the road

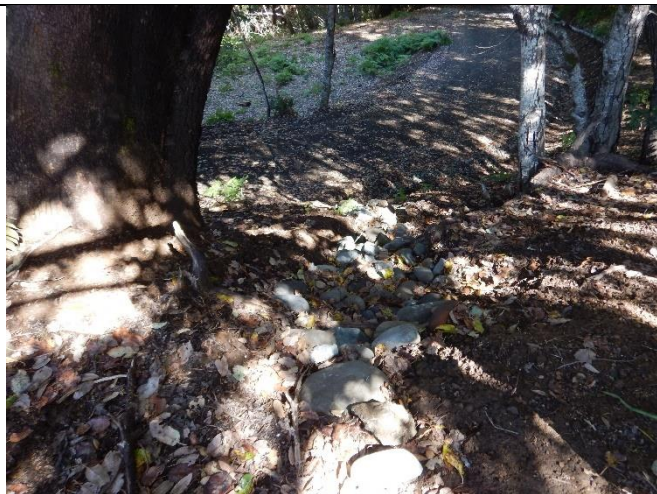
Drainage Path – I observed a rock-lined path conveying water from Cultivation Area 2 to a roadside ditch downhill (photo 7).

Photo 7 – Drainage Path; rock-lined path draining water from Cultivation Area 2

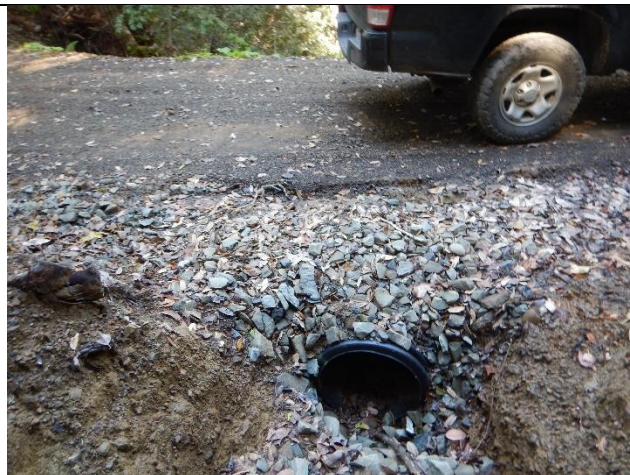
Culvert 4 – I observed an 18-inch diameter recently installed ditch relief culvert with rock surrounding the inlet and outlet (photo 8). The outlet had a downspout attachment to bring the culvert to grade (photo 9). This culvert received flow from a Water Bar Discharge point uphill of the culvert.

Photo 8 – Culvert 4; inlet of ditch relief culvert

4. Monitor Culvert 4 and add large rock at inlet and outlet as necessary
5. Remove and dispose of plastic wattles. Continue revegetation of slopes and place biodegradable wattles as necessary. Line ditch and water bar with rock to minimize erosion and sediment transport

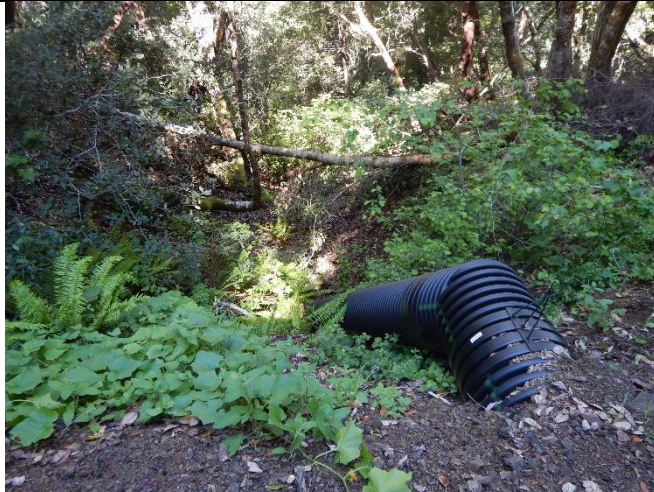
Photo 9 -Culvert 4; downspout of ditch relief culvert

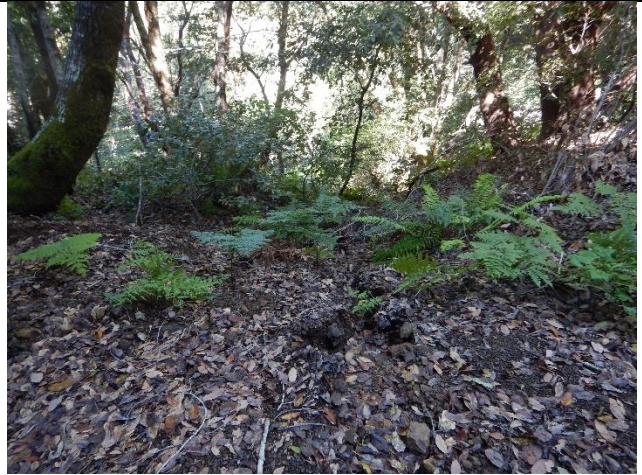
Water Bar Discharge – I observed a water bar on the road above Culvert 4 that had created a channel from excess road runoff (photo 10). Flow from this channel contributed to Culvert 4.

Photo 10 – Water Bar Discharge; discharge point of water bar uphill of Culvert 4

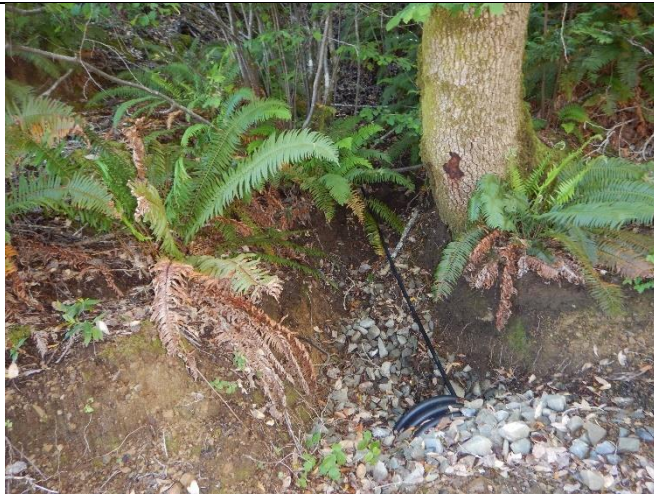
Culvert 5 – I observed an 18-inch diameter recently installed culvert stream crossing with rock surrounding the inlet and outlet (photo 11).

Photo 11 – Culvert 5; inlet of stream crossing culvert

6. Retain a licensed professional to develop a workplan and schedule to:
 - a. Evaluate stream crossings for capacity to convey the 100-flood flow, including debris and sediment loads, and to replace the stream crossings as necessary

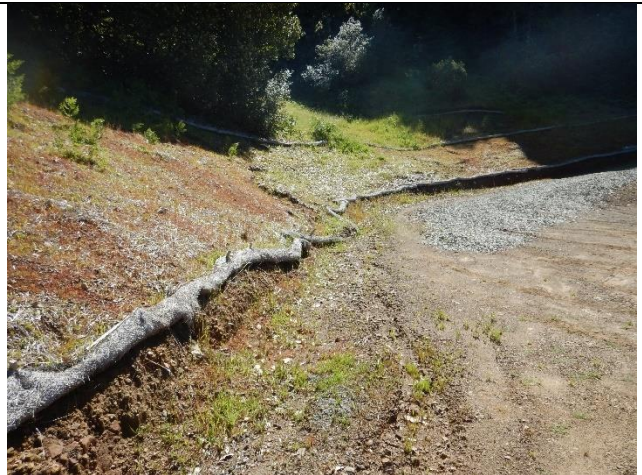
Slope – I observed steep partially-vegetated slopes with plastic netted wattles (photo 12). Some of the wattles had ruptured and were not fully functional.

Photo 12 – Slope; partially vegetated slope with wattles

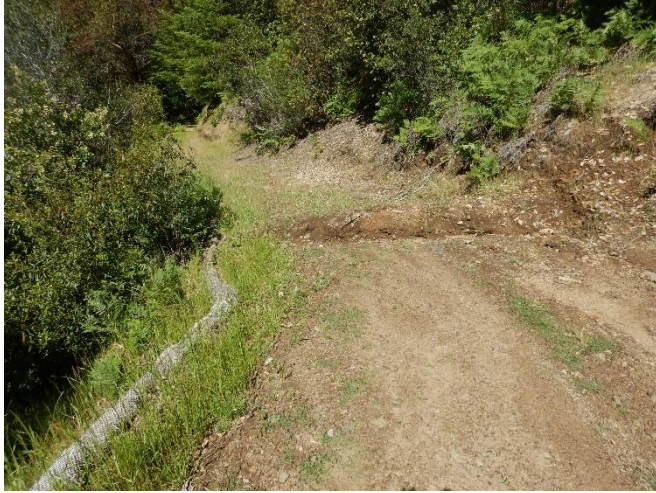
Water Bar – I observed a ditch running along the base of the slope. The ditch stops at the end of the maintained trail, where the ditch hits a water bar, and conveys flow to a vegetated area (photo 13).

Photo 13 – Water Bar; ditch draining flat leads to water bar

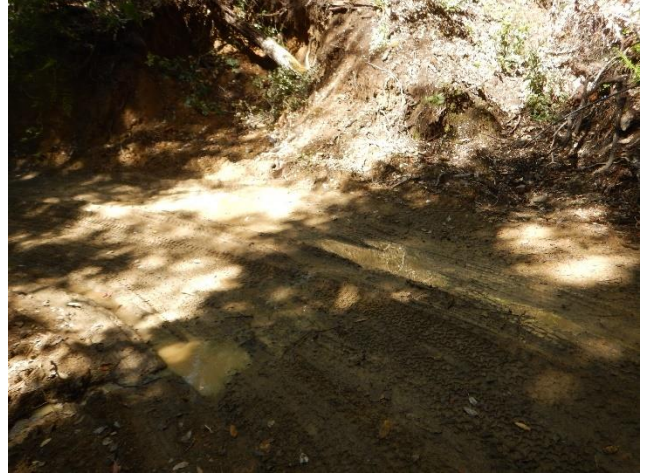
Culvert 1 – I observed a buried culvert stream crossing that was operating as a dirt ford (photo 14). The watercourse was actively eroding sediment from the road surface and conveying it downstream (photo 15).

Photo 14 – Culvert 1; buried culvert stream crossing currently acting as a dirt ford

- b. Improve road alignment, surfacing, and drainage to minimize erosion and sediment transport. Hydrologically disconnect roads and road ditches from watercourses

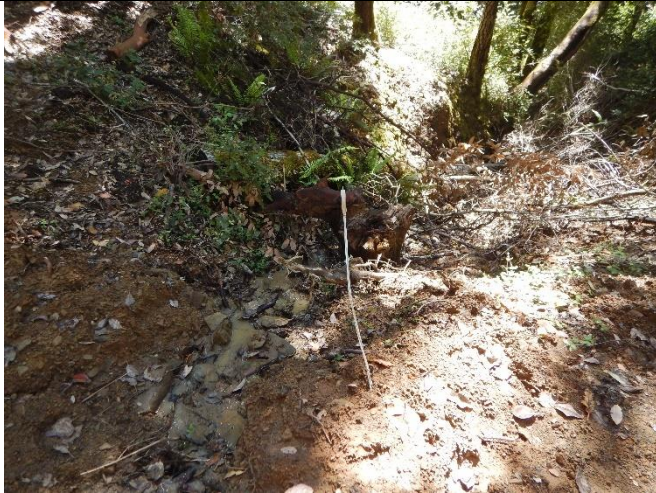
Photo 15 – Culvert 1; muddy road water picked up by watercourse due to buried culvert

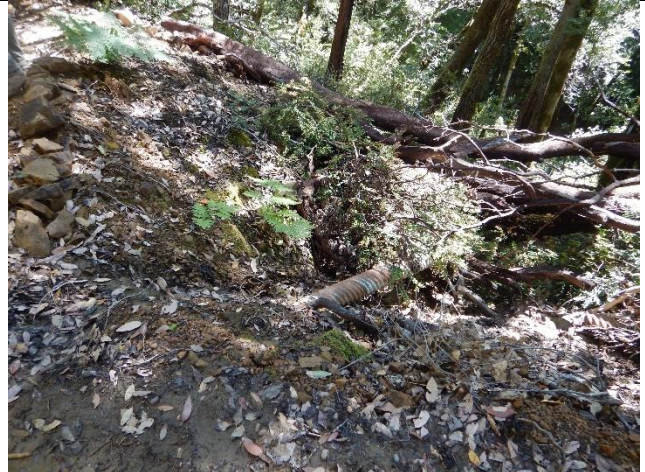
Culvert 2 – I observed a small, rusted culvert stream crossing. The culvert outlet was perched above the channel, causing bed scouring (photo 16).

Photo 16 – Culvert 2; perched and rusted culvert stream crossing outlet

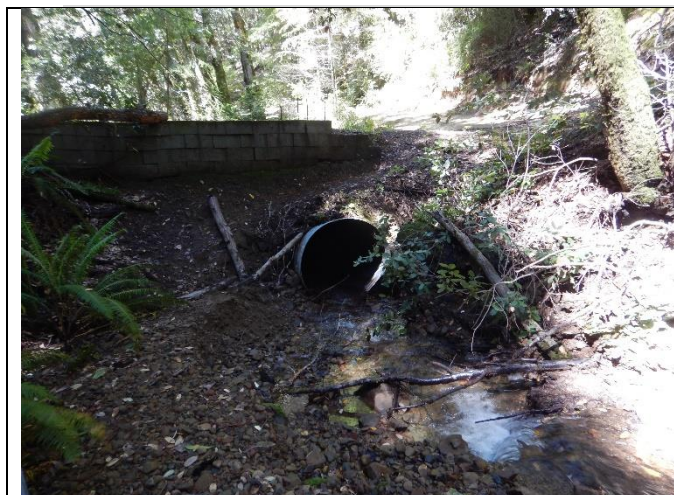
Culvert 3 – I observed a culvert stream crossing on a Class I watercourse (photo 17). The culvert outlet was perched approximately five feet above the channel, causing bed scouring. I took active channel measurements upstream of the culvert and measured a width of 72 inches. Mr. Stafslie stated the culvert had plugged over winter. I also observed road runoff entering the watercourse at the culvert outlet (photo 18).

Photo 17 – Culvert 3; culvert stream crossing

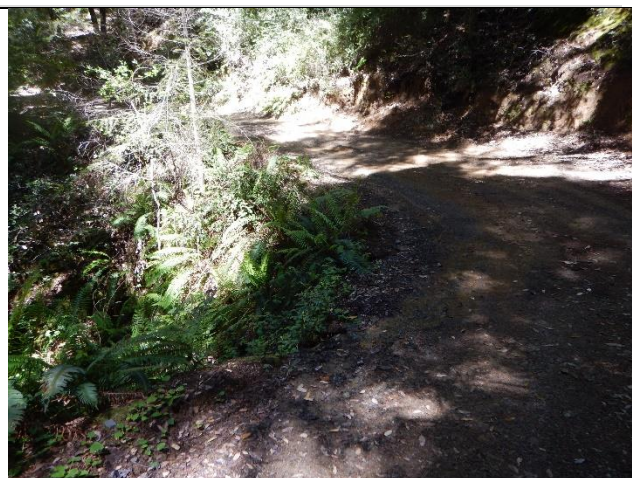
Photo 18 – Culvert 3; road runoff entering watercourse at Culvert 3 outlet
